## Exhibition article

# When Wood Cladding Degenerates

Lessons on durability from traditional wood claddings after long weathering in real conditions

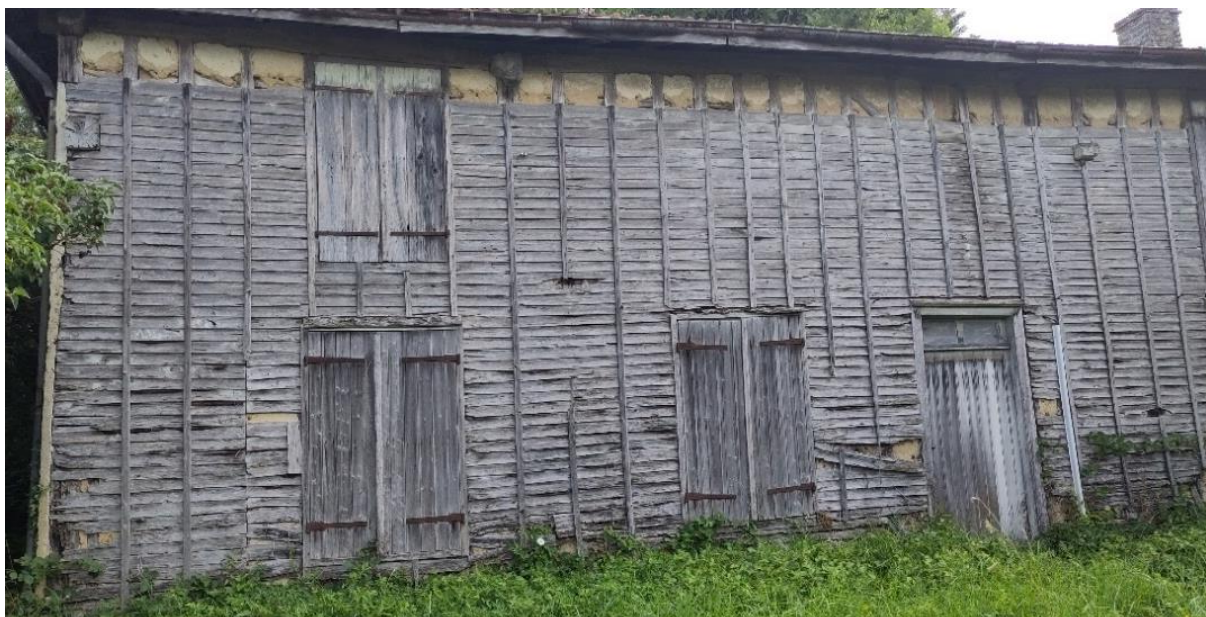
**FIGURE 1.** The South-East façade of a house built with timber-framing and wattle and daub filling in Outines, Champagne, France. *Tavillons* are thin slices of wood cladding the façade, traditionally the most exposed to rain or, like here, facing the main street. They overlap in a horizontal pattern, held in place by vertical wood battens, and often stop a good distance from the roof where they are not needed. They prevent the porous wattle and daub filling from constantly swelling and retracting, making the construction less and less air- and watertight.

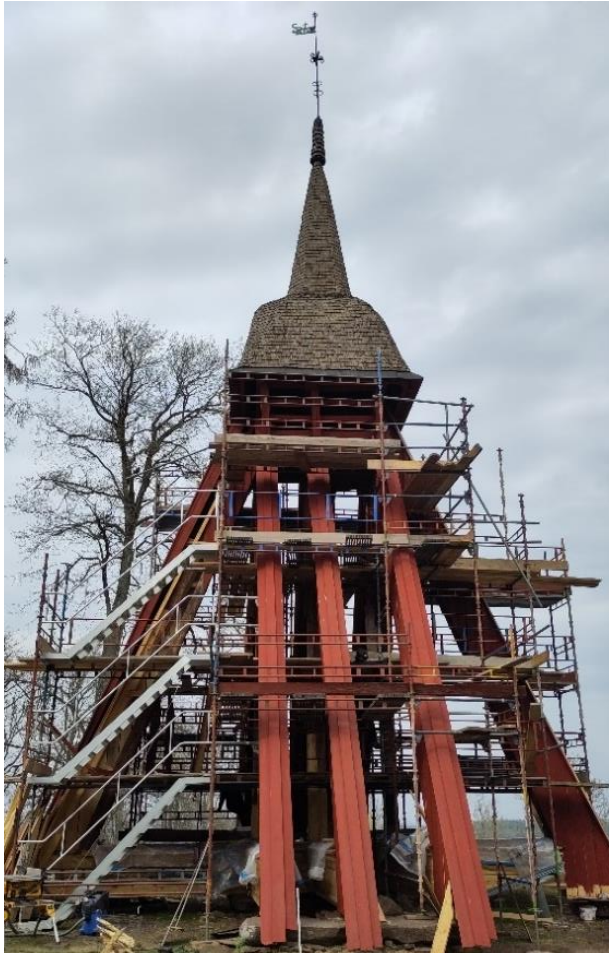
**FIGURE 2.** The belfry of Kungslena church in Skaraborg, Sweden, was built in 1679 and renovated several times, most recently in 2023. During this last renovation, most of the cladding of the lower half was replaced, whereas the higher part, protected by the roof, has probably been standing for hundreds of years and is still preserved today.

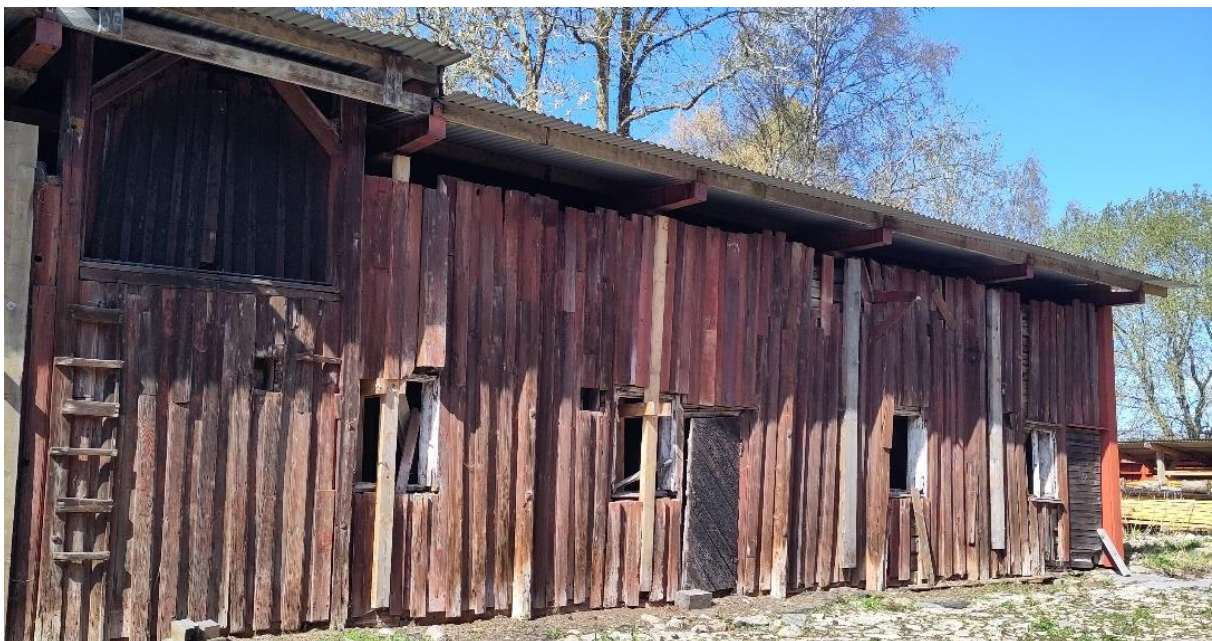
**FIGURE 3.** The stable of Kvibergsnäs, Sweden, was built in the 1780s and its East façade tells many stories. Figure 5 shows an exhibited sample from a panel board belonging to this façade.

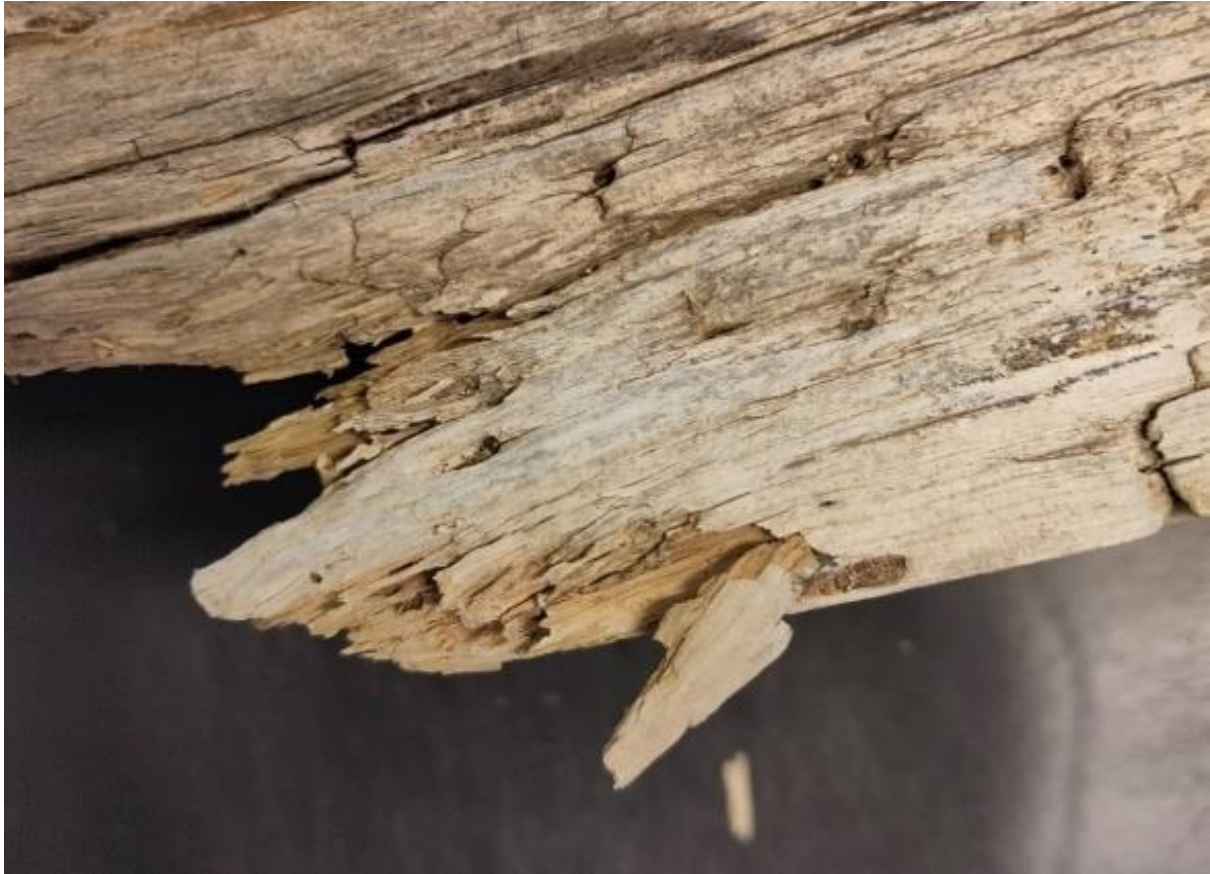
**FIGURE 4.** A sample from the South façade of a barn built with log walls in Västra Götalands, Sweden, and clad with standing boards of Alder. It shows rot in the part that used to be close to the ground. There is no trace of paint and it is likely that it has always been uncoated. Most of the boards are still fixed on the walls today, but they present a large number of insect holes (see Figure 6), especially on the north side, and some rot on the lowest parts of the walls.

In this exhibition, the only board presenting severe rot illustrates why there is a tradition of replacing the parts of cladding most exposed to moisture, which is made possible by the fact that similar elements can be created. In this sense, wood offers the opportunity to build in a regenerative way because it is a material that is grown and biodegradable. Biodegradation is a threat to wood cladding as such but also a chance to build without creating wastes.

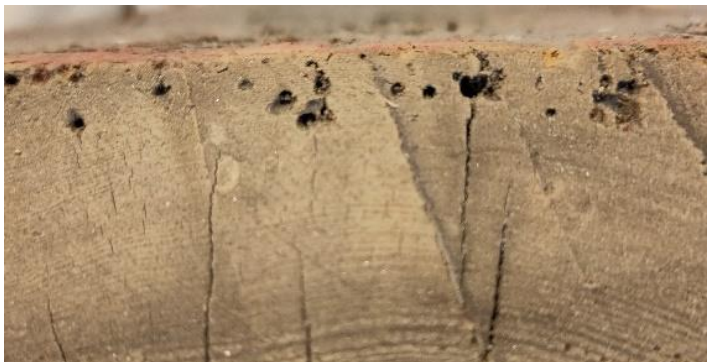
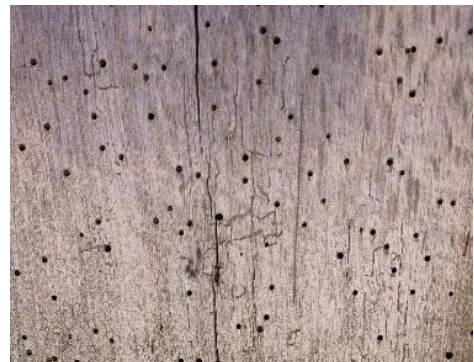
**FIGURES 5 AND 6.** Holes caused by wood-boring insects on a board of Pine coated with Falu red paint, from board-on-board cladding of the stable of Kvibergsnäs, Sweden (Figure 5), and on the same sample as in Figure 4 (Figure 6).

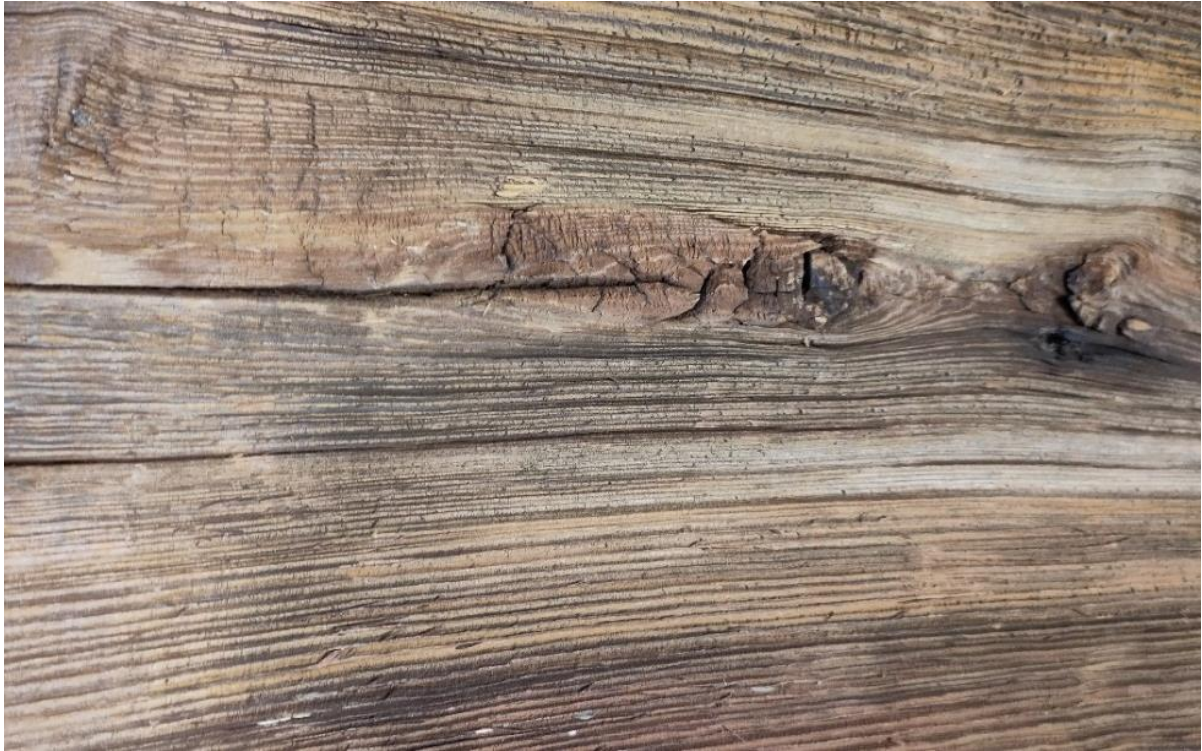
**FIGURE 7.** Checks in the pith area of the tree, on an uncoated board of Pine, from a board-on-board cladding of the South façade of a log house in Örnäs, Skåne, Sweden, from 1865 to 1880. Erosion of the early wood is also observable, while the hard latewood remains, its fibres standing perpendicular to the weathered surface (Almevik, 2012, p. 115). Erosion is a slow process caused primarily by the photodegradation of lignin (by ultraviolet and visible light) and increased by rain and water (Sell et al., 1986, p. 57).

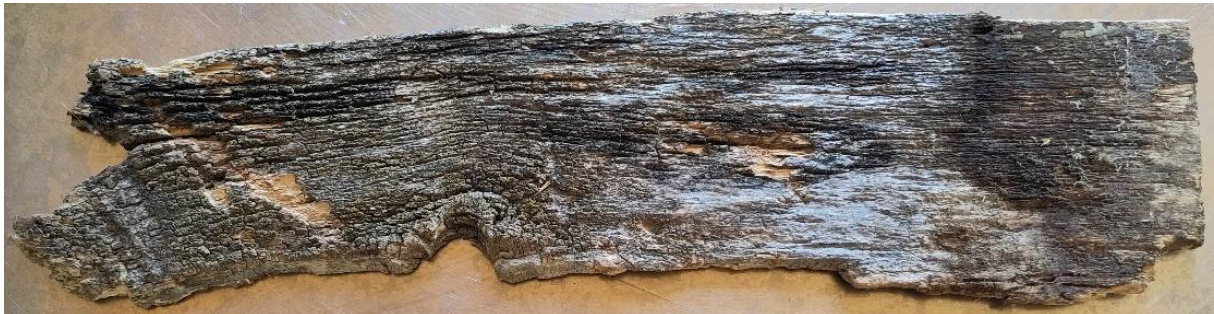
**FIGURE 8.** A sample taken from the lower half of the façade on Figure 1, where the uncoated *tavillons* of deciduous tree, likely *Populus*, are starting to come off after decades without maintenance. It shows less erosion and a different colour, where it was covered by a batten on the right end.

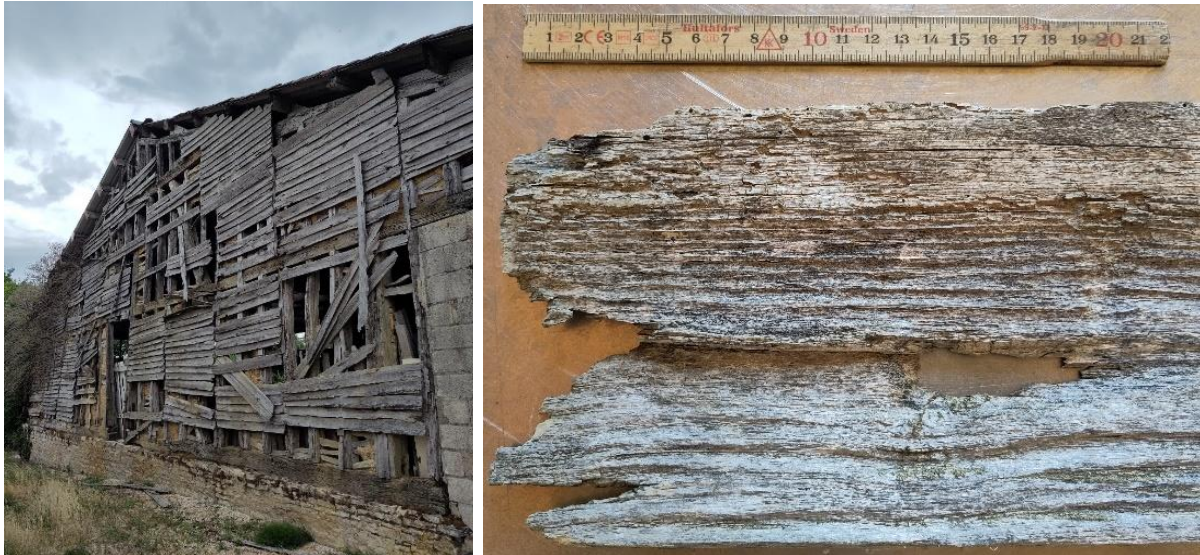
**FIGURES 9 AND 10.** The West façade of a house built with timber-framing and wattle and daub filling in Frampas, Champagne, France (Figure 9). The façade was covered with uncoated *tavillons* made of Alder, many of which came off, leaving the filling unprotected and washed out by the rain. A sample from this façade is showing a nail hole, which has become bigger and where crack formed from it to the edge of the *tavillon* (Figure 10). The abrasion of wood around the nail is mainly due to small movements between wood and metal combined with erosion. It is obvious here that widening of nail holes eventually makes cladding non-functional as a protective layer.
