## Quality of radiation protection aprons and quality control routines at different diagnostic imaging modalities

Linda Wie Bjørkås<sup>1</sup>, Sandra Blø, Magnus Kristoffersen Rekdal<sup>1</sup>, Albertina Rusandu\*<sup>1</sup>

<sup>1</sup>Department of Circulation and Medical Imaging, Norwegian University of Science and Technology (NTNU), Trondheim, Norway.

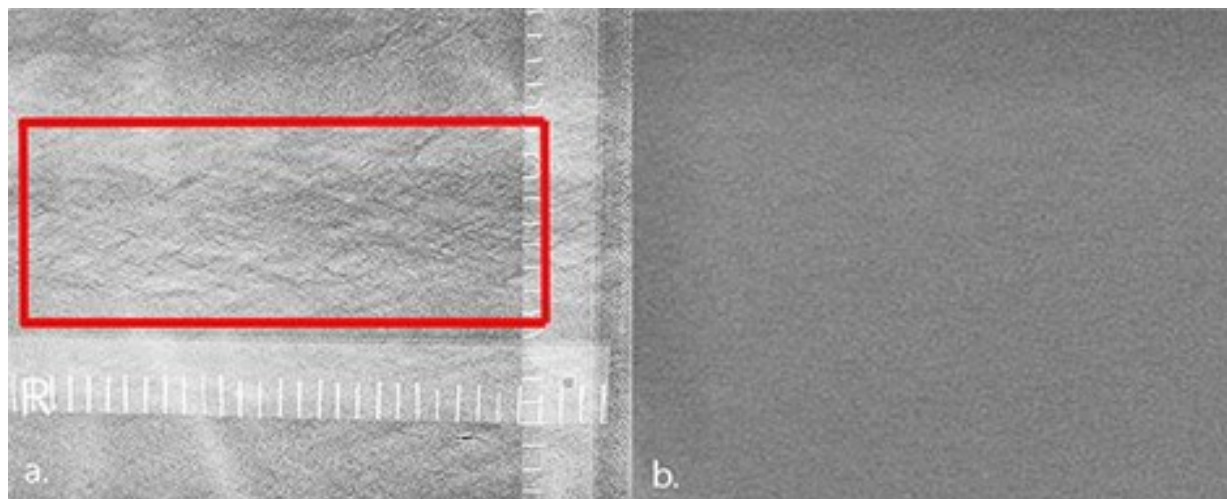
hospital. However, one of the aprons presented some irregularities in the material which might be a sign that the apron has been folded (figure 3). Half of the defects were located at the upper quadrants (table 2).

**Figure 3.** Defective apron (a) and impact apron (b)

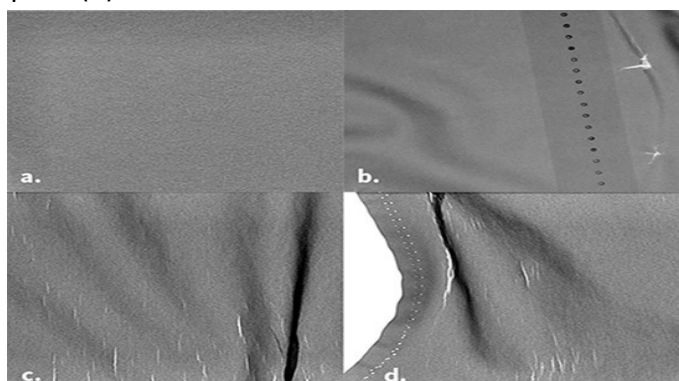
**Figure 4.** Intact apron (a) Rifts (b) Small cracks spread over a large area (c) Apron with a 8 cm crack (d)

The size of the defects was between 1 and 8cm with only two aprons having cracks or tears larger than 2cm. Some aprons had a worn-out appearance with rifts at the edges around the neck and armpits. All three possible lead equivalent values were registered (table 3)

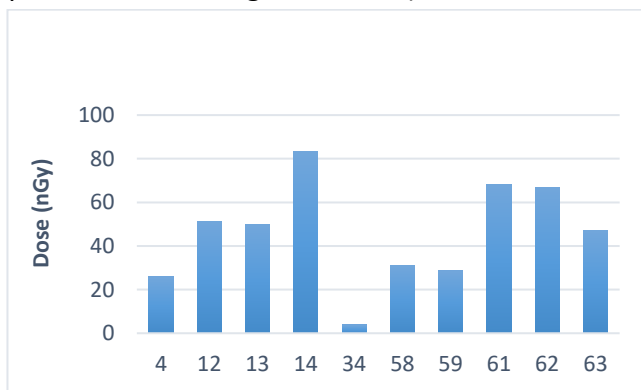
There was registered great variation in radiation dose measured behind the defects (figure 5 and table 5). The differences between doses measured under the defects and under intact apron is shown in figure 6 and 7)

**Figure 5.** Measured dose behind defects in different aprons

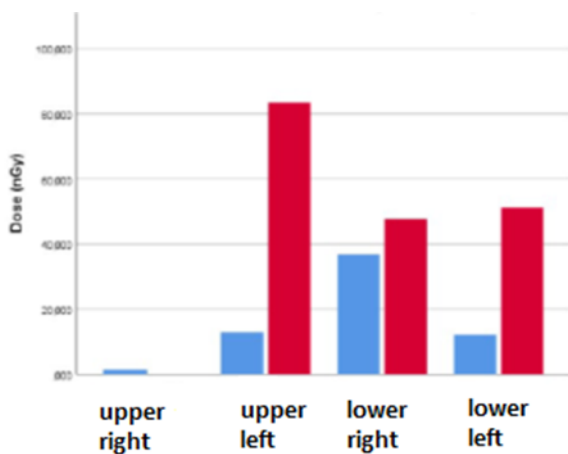
**Figure 6.** Highest measured dose behind the defects in the four quadrants of a 0,25 mm lead equivalent apron compared with the reference dose behind an intact apron

The highest radiation dose was measured behind a 1 cm long defect located in the upper left quadrant of a lead apron with a lead equivalent of 0.25 mm. The radiation dose was 83.37 nGy, which is more than six times higher than the dose behind a corresponding area on the reference lead apron (12.89 nGy) and exceeds the recommended limit of 5% increase in radiation (18) and this might have unforeseen consequences if the user's breast tissue is exposed to the increased radiation dose. However, employees who are aware of such defects would avoid choosing that particular apron (13).

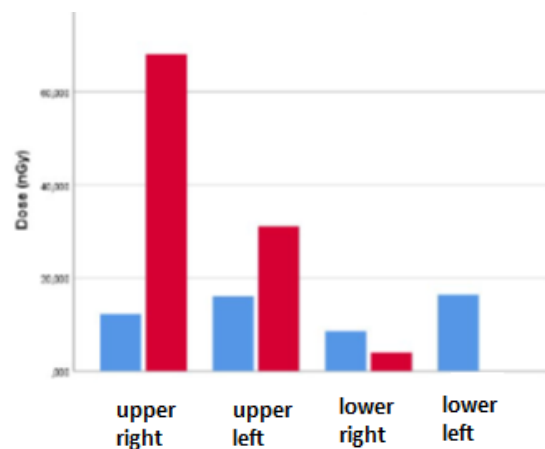
**Figure 7.** Highest measured dose behind the defects in the four quadrants of a 0,35 mm lead equivalent apron compared with the reference dose behind an intact apron

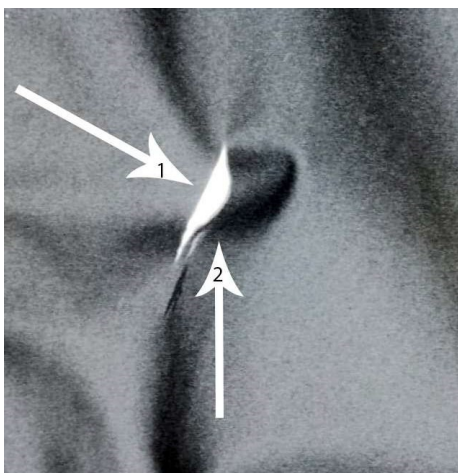
**Figure 7.** Photons hitting the crack with an angle (arrow 1) and photons hitting the crack from the front.

The second highest dose recorded was 68.0 nGy measured behind a crack of 8 cm in a lead apron with a lead equivalence of 0.35 mm. A possible explanation for the lower dose behind this crack which is 7 cm longer than the defect with the highest measured dose may be the angle at which the photons hit the defect. A long and narrow crack can let in photons that hit the lead apron at an angle, while it will stop most frontal hits. In this way, fewer photons hitting the defect from the front will be able to pass through the crack (figure 7).
