Exhibition article

Field Method for Characterization of Deciduous Wooden Shingles

Case study – Historic shingle roofing in Tönnersjö church, Halland, Gothenburg diocese

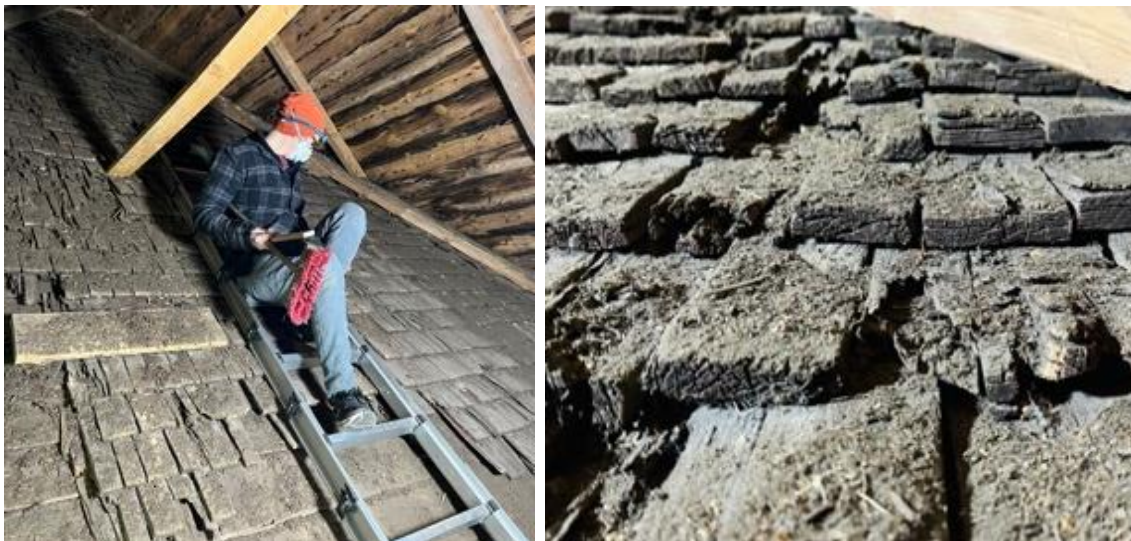
FIGURES 1 AND 2. Built-in historic roofing in Tönnersjö church. To the left, the quite big built-in roof area is shown. The picture to the right shows an uneven spread of oak and aspen shingles on the roof. The built-in roof, about 4m², is a homogenous weathered wood surface, and the shingles appear to have the same age. The shingles are quite narrow and short, approximately 6,5–8 cm in width and 12,5–13 inches long and 20 mm thick in the bottom end. Most of the shingles were in a similar state of deterioration although some of the aspen shingles were in a worse state. Some shingles had very fragile bottom edges and could almost be swept apart.

In the winter of 2023, the authors (re)visited Tönnersjö to document the built-in shingle roof. We quickly realised that even for a trained eye, it was difficult to distinguish the aspen and oak shingles from each other (figs. 1 and 2). We started to clean the surface carefully (with a soft brush in the direction of the wood fibres) from a thick layer of dirt. The most important tools were LED lamps with different

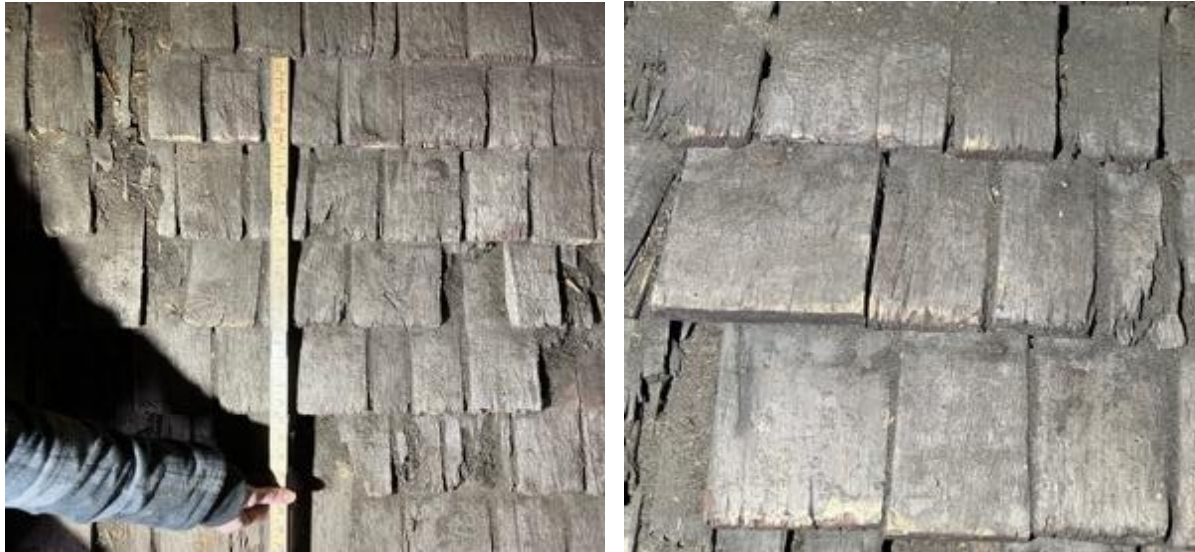
FIGURES 3 AND 4. Left: The length of the “bleke” (visible part) is 12–13 cm/5 inches. The bottom row of shingles, at the eaves, are cut rounded with axe while all the others are cut straight. Right: A handful of oak shingles seem to be of younger age and the result of repairs, as they are nailed on the visible part of the shingle. Differences noted in oak and aspen shingles are that the aspen shingles are insect infested. This feature was diagnostic in this case but is not a general indicator of aspen. When the aspen surface is damp, it peels off like wet cardboard if you rub it (not when the wood is dry). Cracks appear in the face of the aspen shingles. When raking light is used and moved over the surface, the aspen shingles appear to be slightly more silvery, shiny grey than the oak shingles. The oak shingles have narrow tree rings, but as the shingles’ top surfaces are weathered, it is not so easy to see (this feature is site specific). The oak was split radially with cracks, following medullary rays that are easy to interpret incorrectly as annual rings. The oak surface does not have a texture as soft as aspen’s.

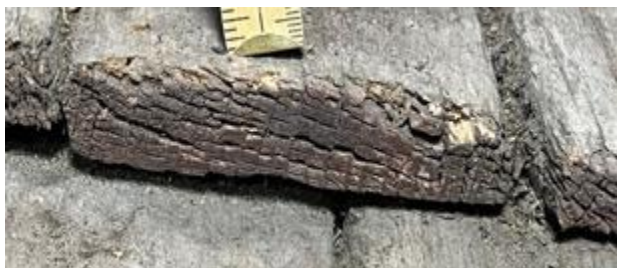
FIGURE 5. One of the aspen shingles was confirmed with dendroanalysis and it contained 26 annual rings.

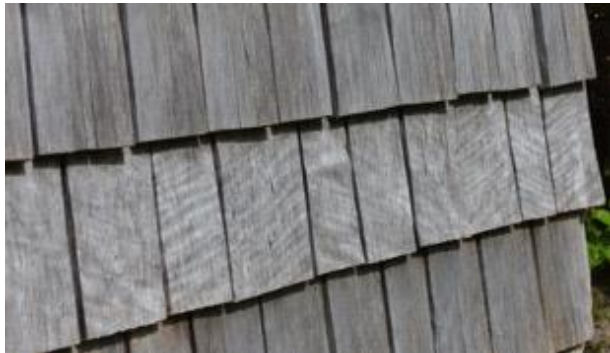
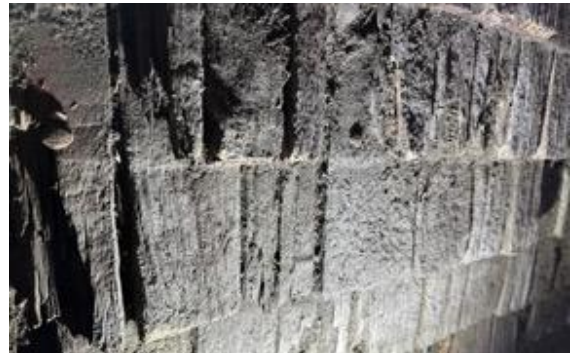
FIGURES 6 AND 7. To the left is a 20-year-old display screen that shows pine and aspen shingles. The middle row is made of aspen and has a wavy and silvery character compared with the straight and more grey pine shingles. The test screen was made by co-author Börje Samuelsson. To the right, an old surface from Tönnersjö also has a wavy and silvery look.

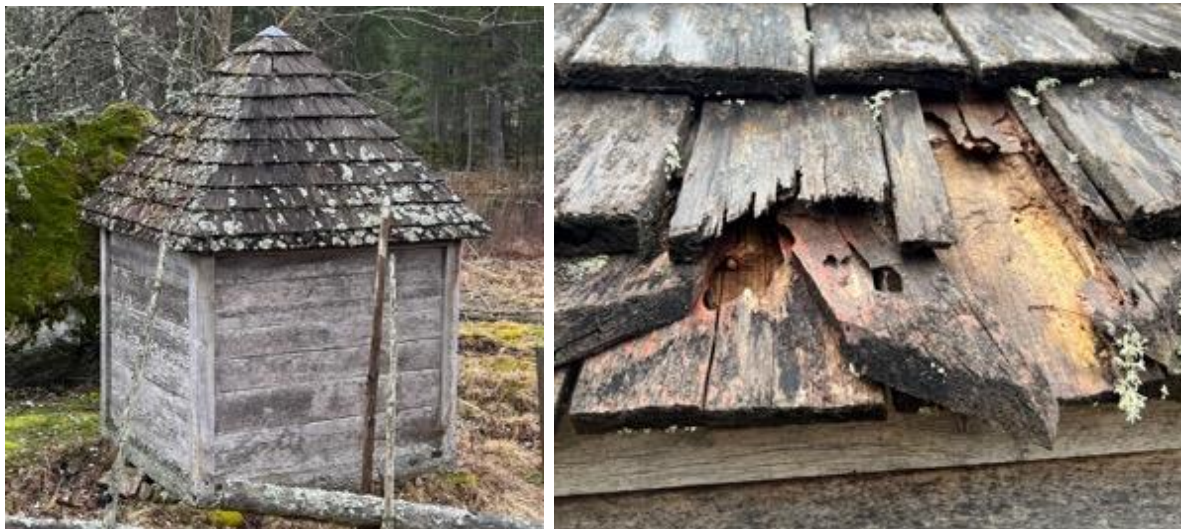
FIGURE 8 AND 9. To the left: The aspen roof is still in good condition even though it is shaded by vegetation. A few of the shingles have deteriorated. To the right: As in Tönnersjö, the shingles have a soft surface that can be peeled off. However, we saw no insect holes. Börje used aspen trees with few branches and a diameter of about 25 cm. The shiny silvery grey surface was obvious and reminded of photos of Russian aspen roofs from the Kizhi outdoor museum and roofs on churches in Åland.

Co-author Börje Samuelsson carried out experiments 20–25 years ago inspired by roofs in Finland and Russia (fig. 17 and 18). On a small well house, about 1,5 m x 1,5 m, with pyramidal roof he used aspen shingles. We examined this roof, which had never been repaired or tared. We identified some features in the deteriorated surface that were similar to what we saw in Tönnersjö. This helps us calibrate and understand our observations of historic roofs.
